# **UVDECHLO**DD300 ECOENERGY

Flow rate: from 200 to 300 m<sup>3</sup>/h

**REF**: 23000152

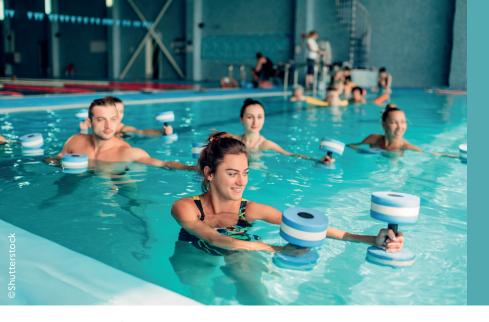
The **UVDECHLO DD300** reduces the level of combined chlorine in swimming pools through a photochemical action on all organochlorine compounds found in the water (monochloramine, dichloramine trichloramine). It also destroys Giardia and Cryptosporidum.

The dechloramination unit must be installed horizontally: water flow can be in either direction, but we recommend that the water flows in from the top and out from the top of the unit to avoid any accumulation of air in the treatment chamber and to ensure that it always remains full of water. Sufficient clearance must be provided along the dechloramination unit (1.30 m) to allow for maintenance and UV lamp replacement.

Filtration is required to remove suspended solids. The dechloramination unit is therefore installed after the pool filters, but before chlorine injection as the chlorine molecules can be degraded by UV radiation.

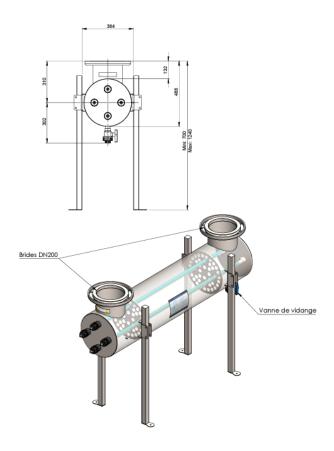
# **UVDECHLO** DD300 ECOENERGY

Flow rate: from 200 to 300 m<sup>3</sup>/h

### **INSTALLATION**
