DECHLO RANGE

UVDECHLO AD300 ECOENERGY

Flow rate: from 10 to 50 m³/h

REF: 23000093

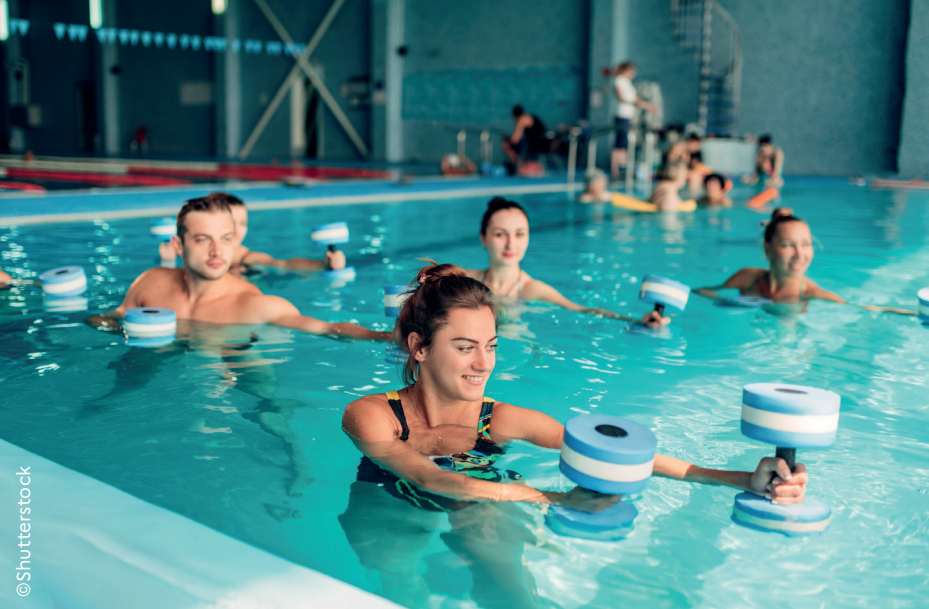
The **UVDECHLO AD300** reduces the level of combined chlorine in swimming pools through a photochemical action on all organochlorine compounds found in the water (monochloramine, dichloramine trichloramine). It also destroys Giardia and Cryptosporidium.
