DECHLO RANGE

PUBLIC SWIMMING POOLS
WELLNESS AREAS
SPAS
THALASSOTHERAPY &
BALNEOTHERAPY
HYDROTHERAPY

UVDECHLO CD300 ECOENERGY

REF: 23000126

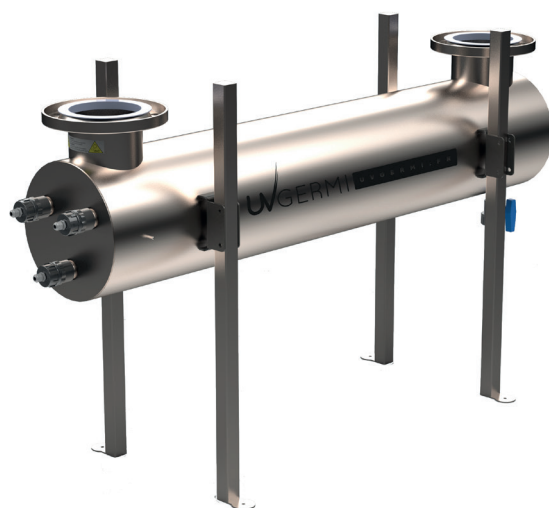
The **UVDECHLO CD300** reduces the level of combined chlorine in swimming pools through a photochemical action on all organochlorine compounds found in the water (monochloramine, dichloramine trichloramine). It also destroys Giardia and Cryptosporidium.
