UVDECHLO CD300 ECOENERGY Flow rate: from 100 to 200 m³/h

The UVDECHLO CD300 reduces the level of combined chlorine in swimming pools through a photochemical action on all organochlorine compounds found in the water (monochloramine, dichloramine trichloramine). It also destroys Giardia and Cryptosporidum.

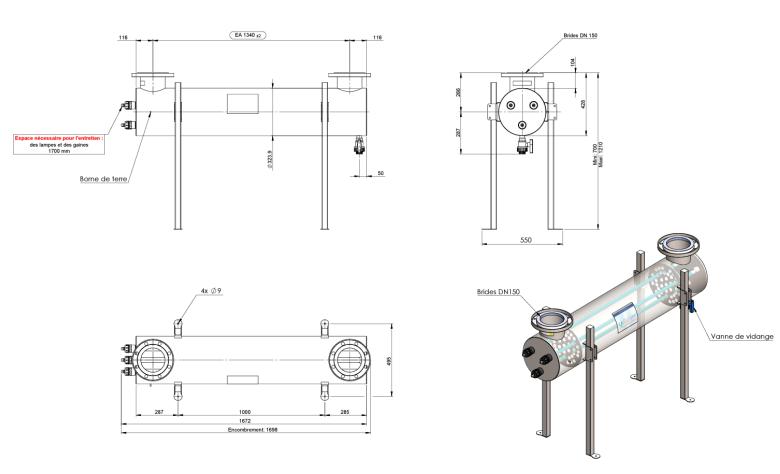
INSTALLATION

The dechloramination unit must be installed horizontally: water flow can be in either direction, but we recommend that the water flows in from the top and out from the top of the unit to avoid any accumulation of air in the treatment chamber and to ensure that it always remains full of water. Sufficient clearance must be provided along the dechloramination unit (1.70 m) to allow for maintenance and UV lamp replacement.

Filtration is required to remove suspended solids. The dechloramination unit is therefore installed after the pool filters, but before chlorine injection as the chlorine molecules can be degraded by UV radiation.

Loss of efficiency occurs when the UV lamps reach the end of their service life (after 2 years of operation) or if one of them becomes defective. They must be replaced. The quartz sleeves make lamp replacement much easier: the unit does not have to be drained or dismantled. The dechloramination unit is equipped with several lamps, which must all be replaced at the same time.

The quartz sleeves may become clogged and should be cleaned once a year with a mild acid. Seals on the quartz sleeves must be replaced every time they are dismantled, and at least every two years.
