# **UVDECHLO**FD600 ECOENERGY

Flow rate: from 450 to 900 m<sup>3</sup>/h

**REF**: 19000276

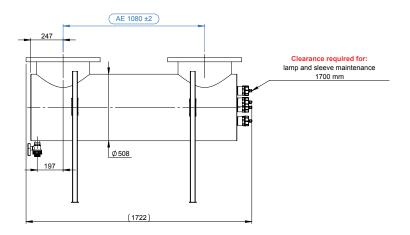
# **UVDECHLO FD600 ECOENERGY**

Treatment chamber:	Stainless steel 316L
Input/Output:	DN 400/PVC 400
Operating pressure:	2 bars

Dimensions (mm):
 600 x 800 x 400

Flow rate: from 450 to 900 m<sup>3</sup>/h

The dechloramination unit must be installed horizontally: water flow can be in either direction, but we recommend that the water flows in from the top and out from the top of the unit to avoid any accumulation of air in the treatment chamber and to ensure that it always remains full of water. Sufficient clearance must be provided along the dechloramination unit (1.70 m) to allow for maintenance and UV lamp replacement.
